Reliability and Maintainability Evaluation of the Mode S System

Prepared By
FAA Technical Center
Atlantic City Airport, N.J. 08405

May 1982

Final Report

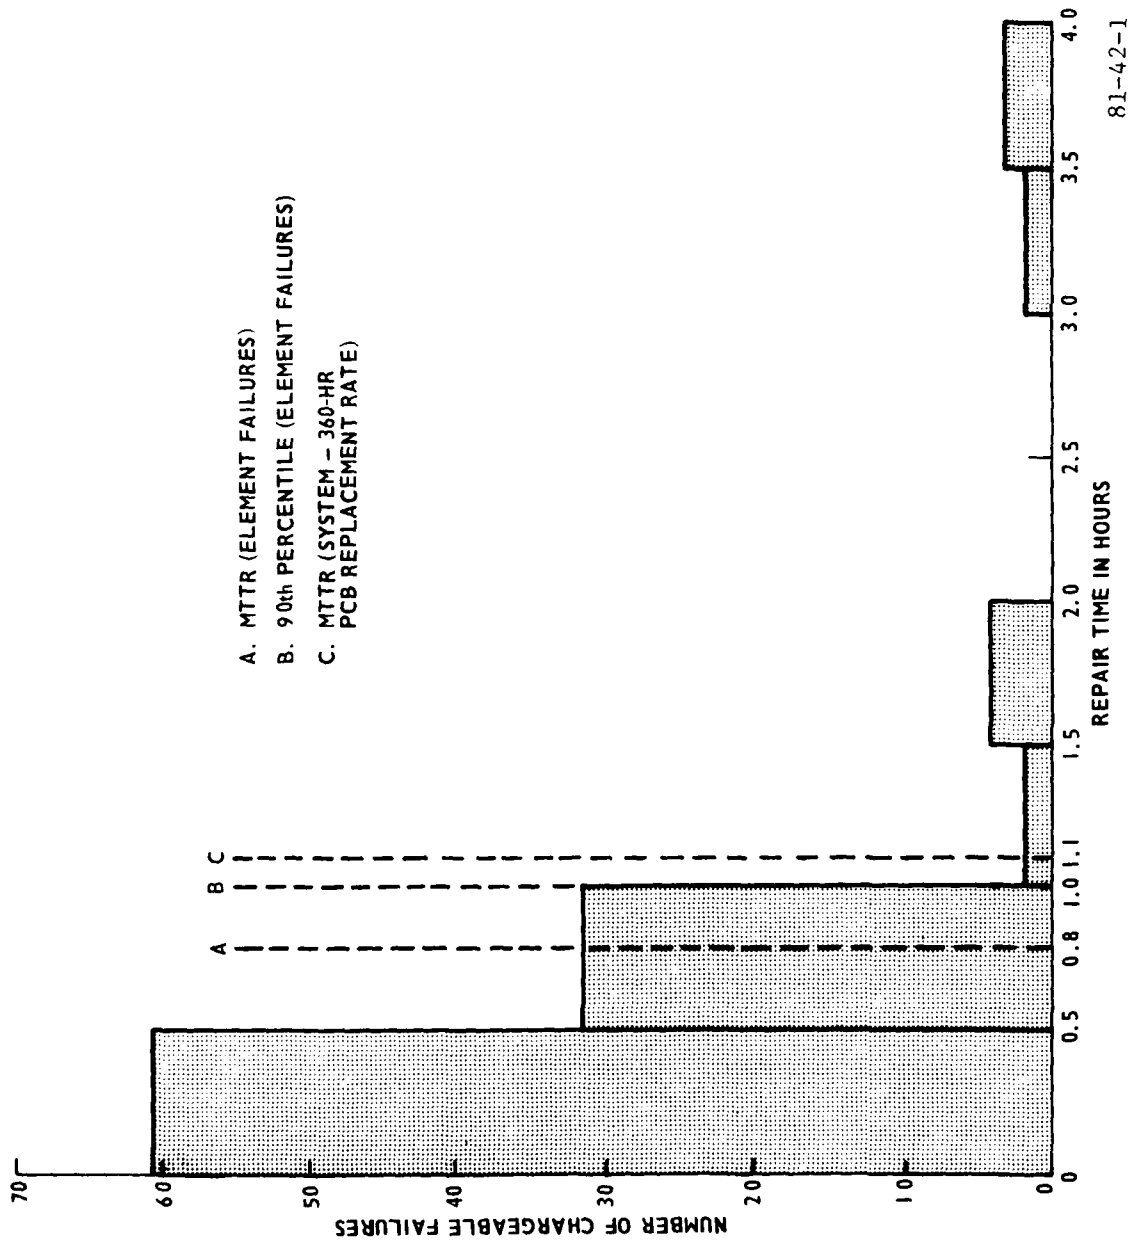
OVERALL MTTR. Figure 1 is a histogram of the repair times of the 104 total chargeable failures incurred by the individual elements of all three sensors. This shows that the repair times of the element failures appear to be exponentially distributed. The MTTR of these 104 failures is 0.8 hour and is shown as line "A" in figure 1. This meets the requirement of paragraph 3.9.4.1(i), FAA-ER-240-26, that the mean corrective maintenance time shall not exceed 1 hour. The 90th percentile value of maximum repair times is approximately 1 hour and is shown as line "B" of figure 1. This is below the 2-hour maximum requirement specified in the same paragraph of the engineering requirement. The measured system MTTR of 1.1 hour (for the 360-hour replacement rate) is shown as line "C" in figure 1.

FIGURE 1. DISTRIBUTION OF REPAIR TIMES OF OVERALL CHARGEABLE FAILURES
